**ASHLAND DAM**

**PHASE I INSPECTION REPORT  
NATIONAL DAM INSPECTION PROGRAM**

ASHLAND DAM  
SCHUYLKILL COUNTY, PENNSYLVANIA  
NATIONAL I.D. NO. PA 00659-  
671

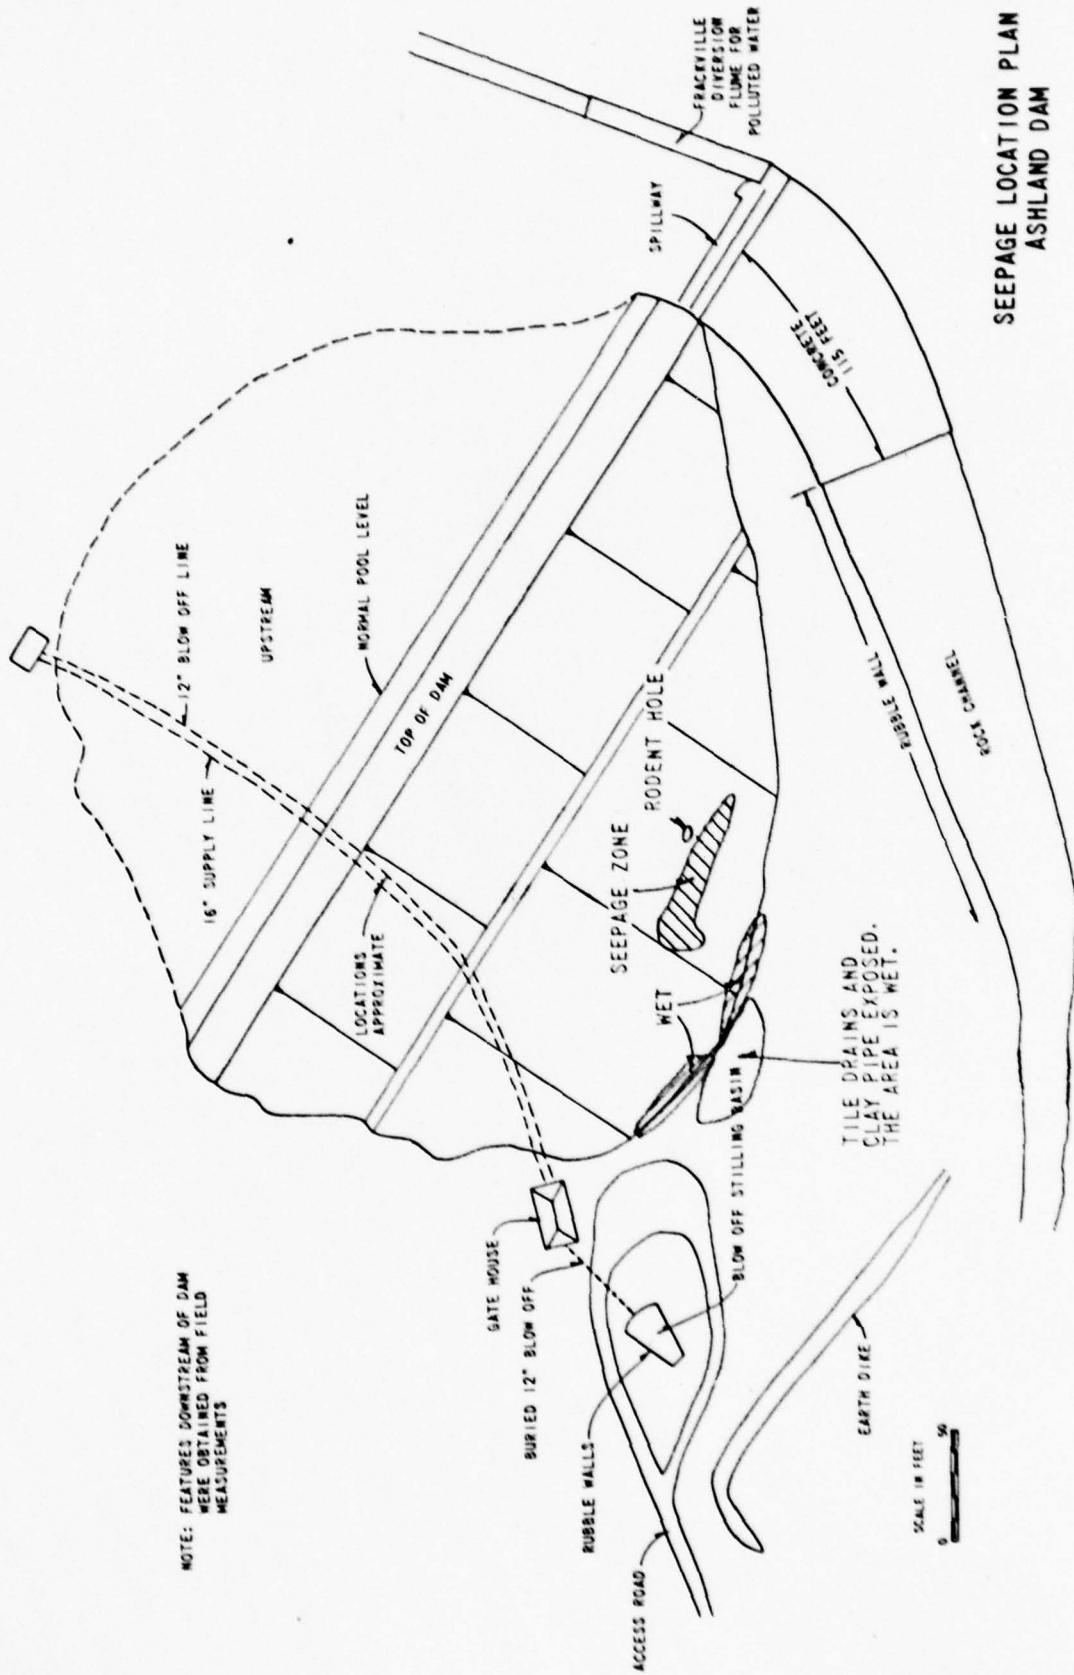
b. Dam. During the visual survey, there was no evidence of embankment distortion or crest subsidence that would be indicative of foundation settlement, movement or imminent failure of the embankment and along the toe in the vicinity of the french drain system. Exposed portions of the french drains were inspected and noted to be functioning. The seepage noted on the downstream face was compared to a photograph taken on 16 May 1939 by Mr. E. G. Langan, DER, and the seepage noted in that photograph was compared to seepage noted during this 1978 inspection. There has apparently been no change in seepage rates or location since 1939. In fact, the location of seepage noted in the 1978 inspection was confined to the left portion of the downstream embankment. Seepage is shown on sheet 5a, Appendix B. Photographs of the seepage are shown in Appendix D.

Seepage was noted downstream along the embankment as shown on Sheet 5a, Appendix B. This seepage was also noted during a 1939 inspection and, based on the observations at that time, there appears to be no significant increase in the seepage rates since that inspection. However, this seepage is undesirable and should be monitored. The downstream toe area was damp and marshy along the right abutment as shown on Sheet 5a of Appendix B. Evaluation of this area showed the terra-cotta pipe and the tile drains installed in 1938 to control downstream toe leakage were functioning.

5. The rodent hole noted as shown on Sheet 5a, Appendix B should be filled.

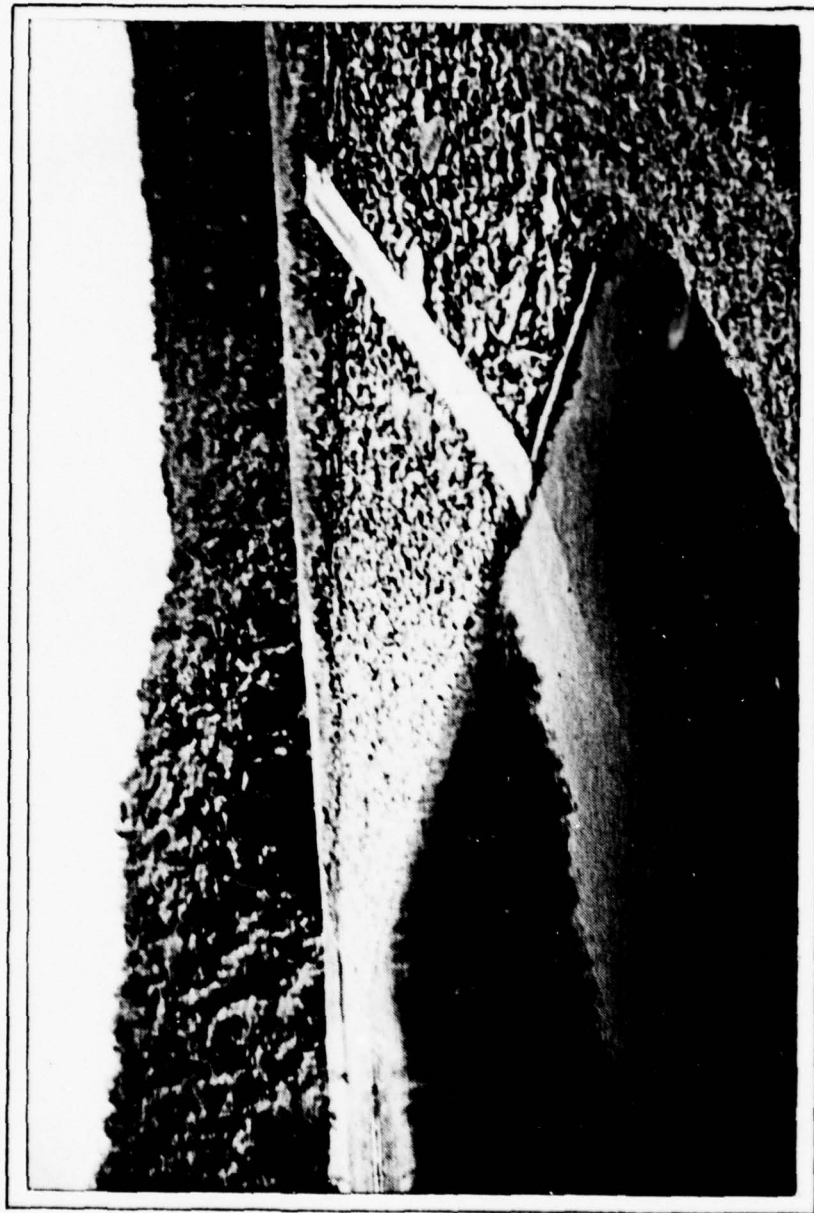
The upstream riprap was inspected above the water line and observed to be in good condition with no signs of movement or significant deterioration. Embankment/abutment contacts were inspected and observed to be in good condition.

VIEW OF UPSTREAM SLOPE. NOTE GOOD  
CONDITION OF RIPRAP AND STAFF GAGE.

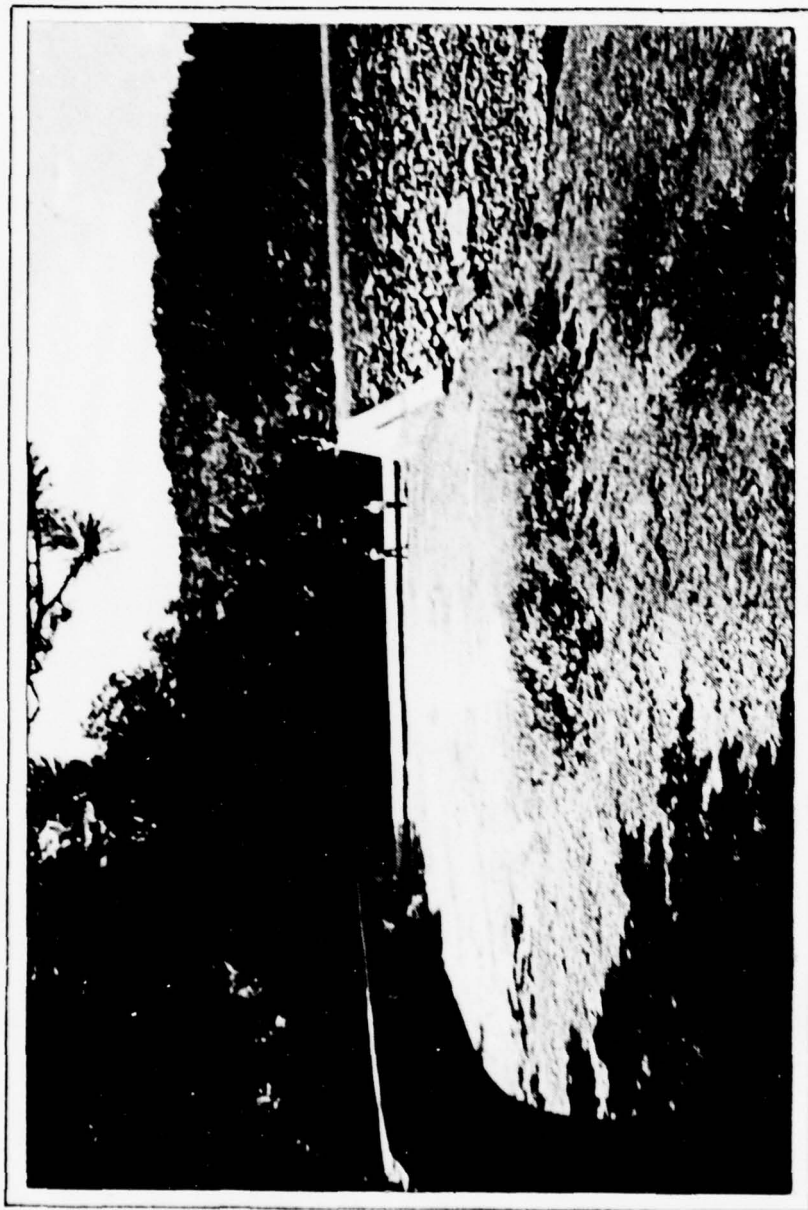
PHOTOGRAPH NO. 2

APPROACH CHANNEL TO EMERGENCY  
SPILLWAY.

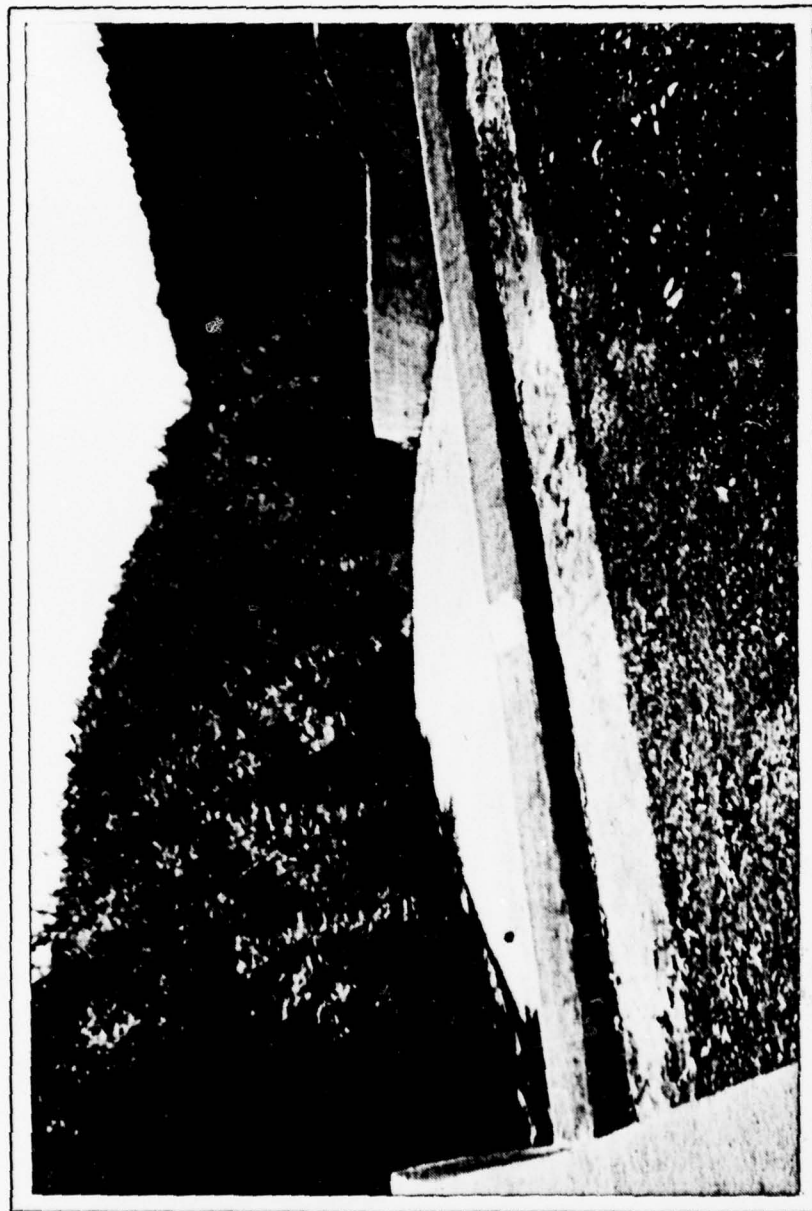
PHOTOGRAPH NO. 3

EMERGENCY SPILLWAY CREST.

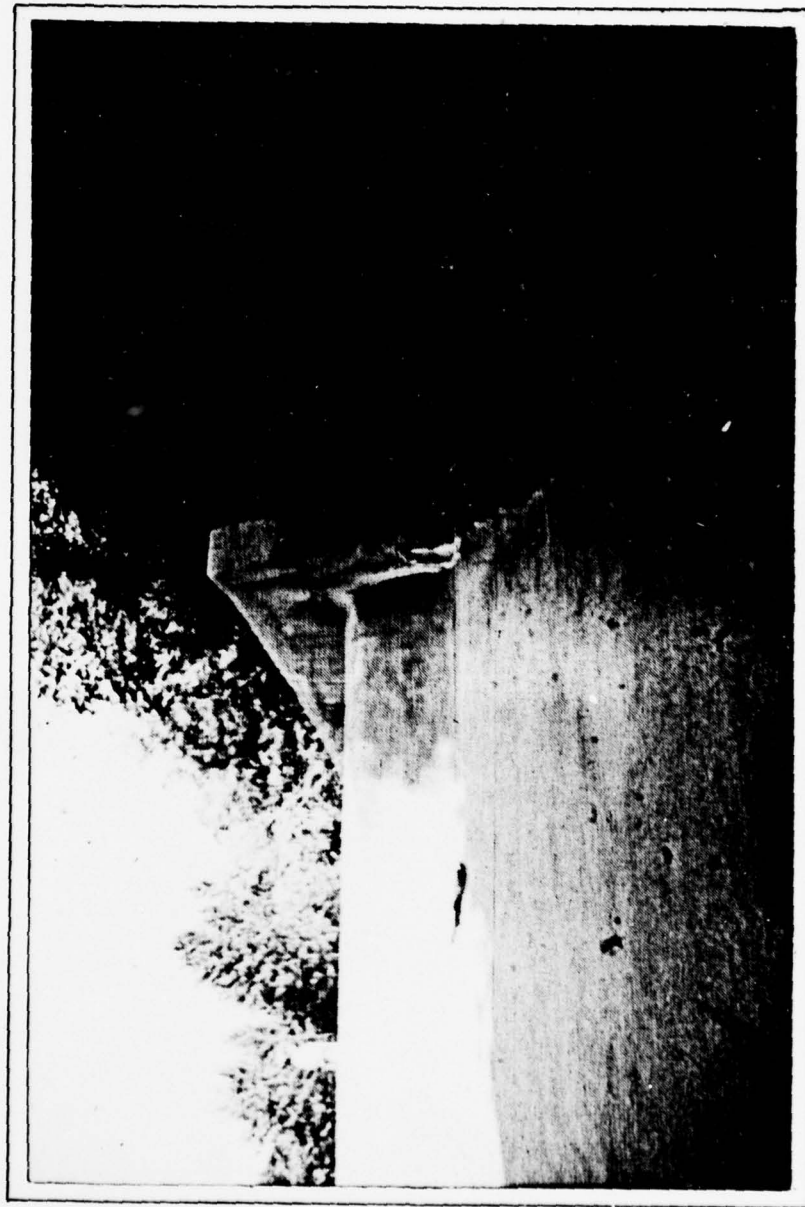
VIEW LOOKING UPSTREAM TOWARDS CREST  
OF EMERGENCY SPILLWAY. NOTE OUTFLOW  
FROM DIVERTED CHANNEL. POLLUTED  
STREAM IS DEVERTED AROUND RESERVOIR  
VIA THIS CHANNEL.

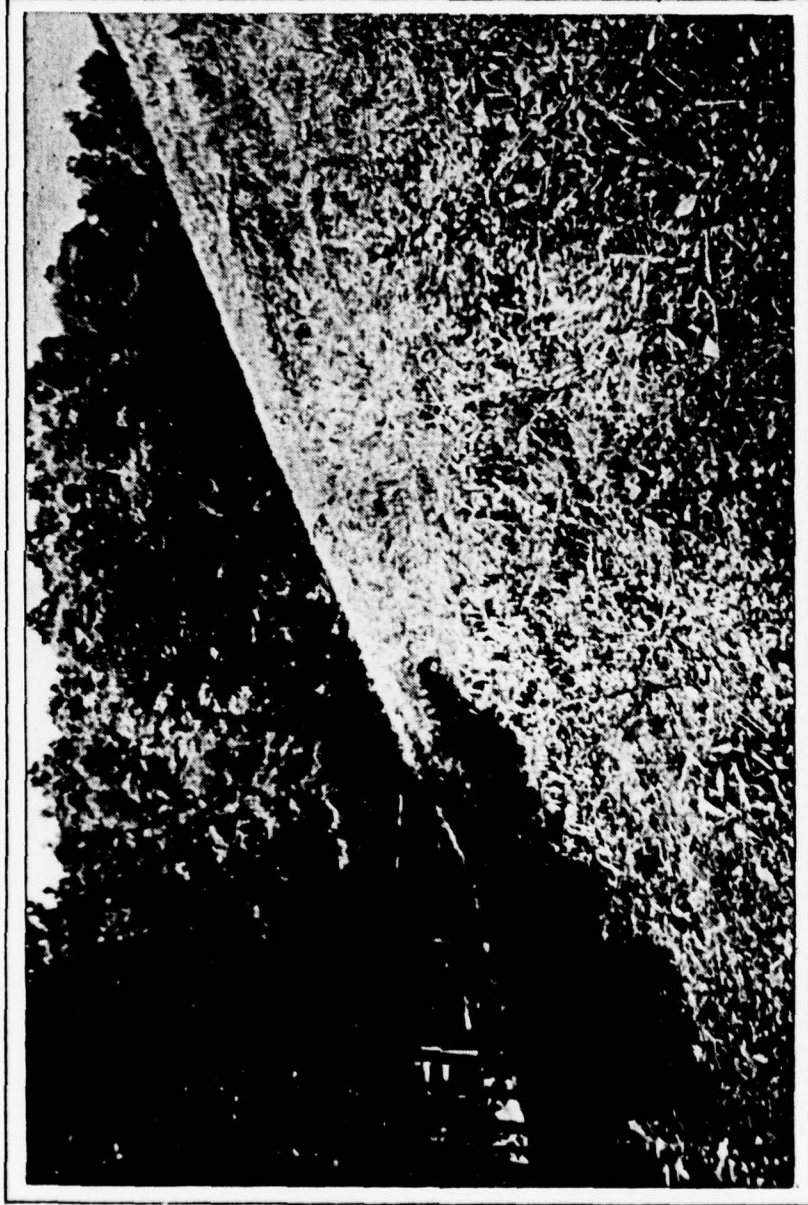
VIEW OF DOWNSTREAM SLOPE LOOKING  
TOWARDS RIGHT ABUTMENT. SEEPAGE  
IS LOCATED IN THE FOREGROUND.  
SEE PHOTOGRAPH NO. 9.

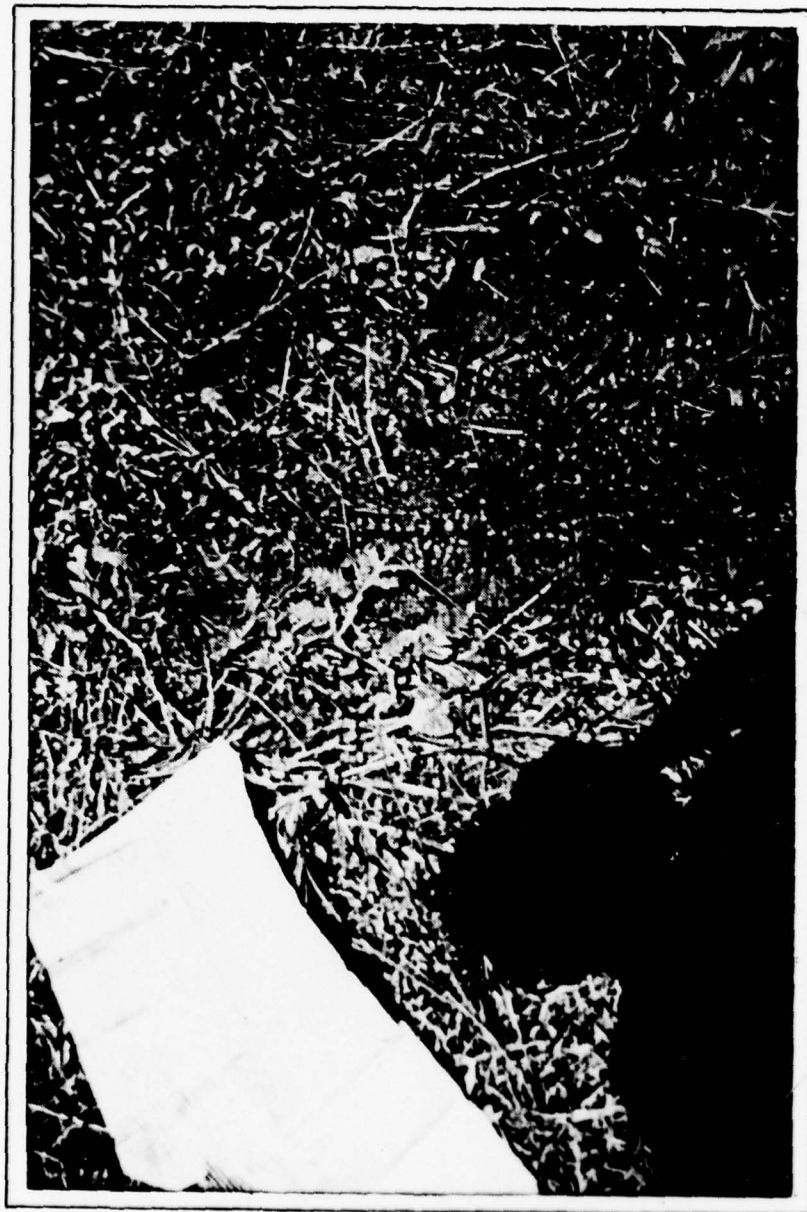
SEEPAGE NOTED THROUGH DOWNSTREAM  
SLOPE. SEE SHEET 5a OF APPENDIX  
B FOR EXACT LOCATION.

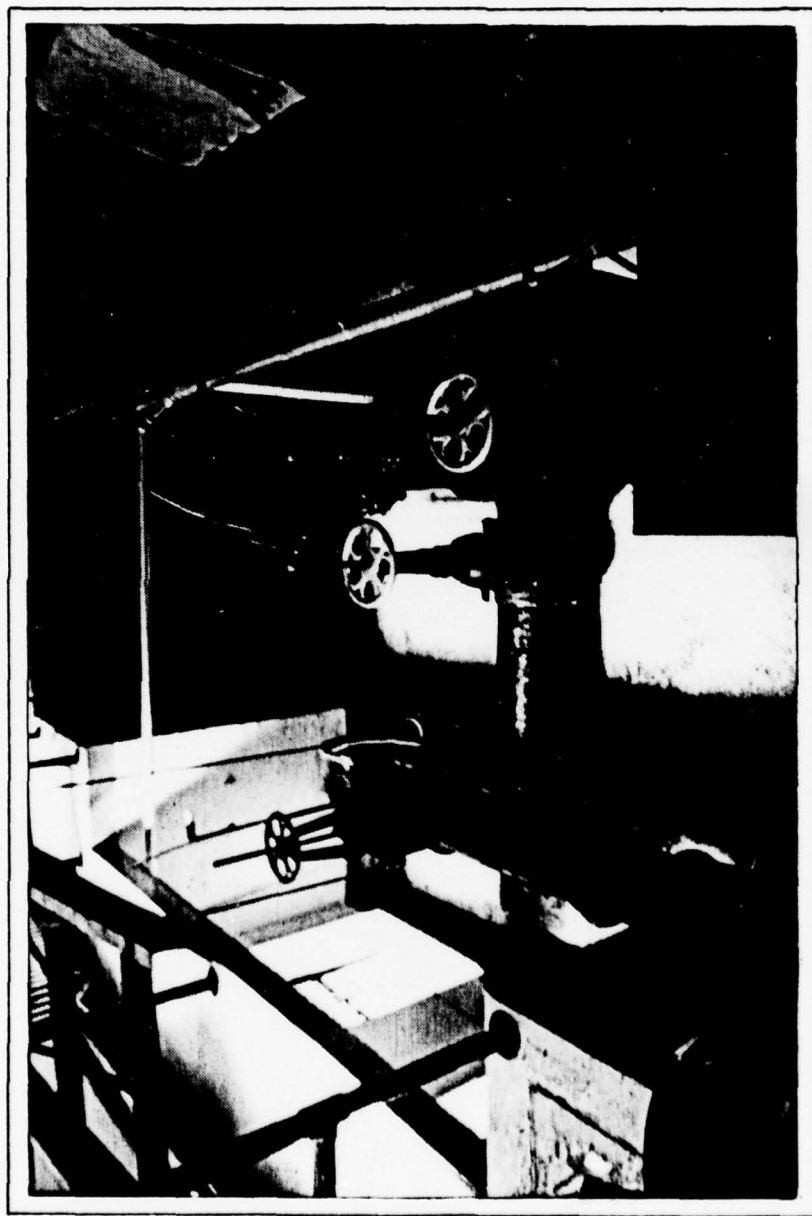
PHOTOGRAPH NO. 11

There are no written maintenance procedures for the dam. Since the dam was completed in 1925, there are no records to indicate that the blow-off or water supply pipes have been checked. The portions of the pipe located in the treatment building are periodically cleaned, painted and are kept in very good condition. The valves were also inspected and found to be clean, well lubricated and operating properly.

WATER SUPPLY CONTROL VALVES ARE  
LOCATED IN CONTROL HOUSE.

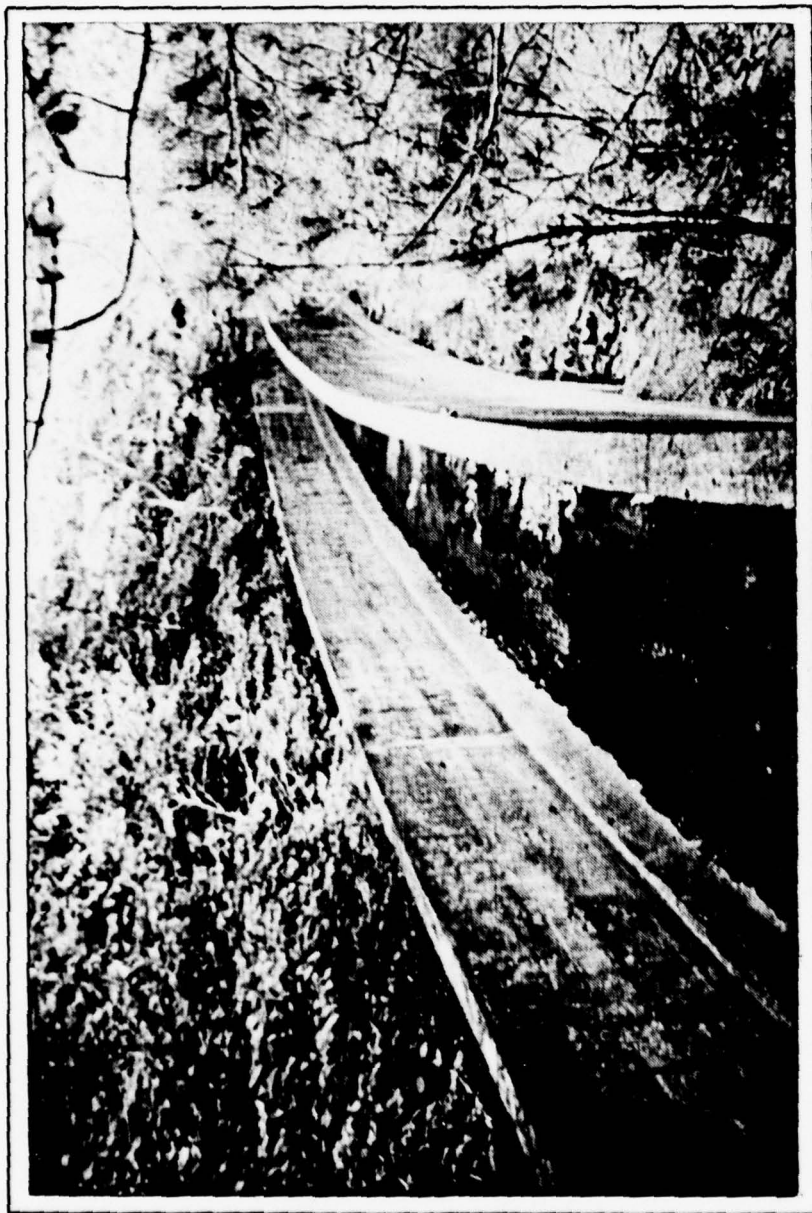
PHOTOGRAPH NO. 12

CONCRETE DIVERSION CONDUIT USED  
TO TRANSFER POLLUTED WATER AROUND  
THE RESERVOIR.

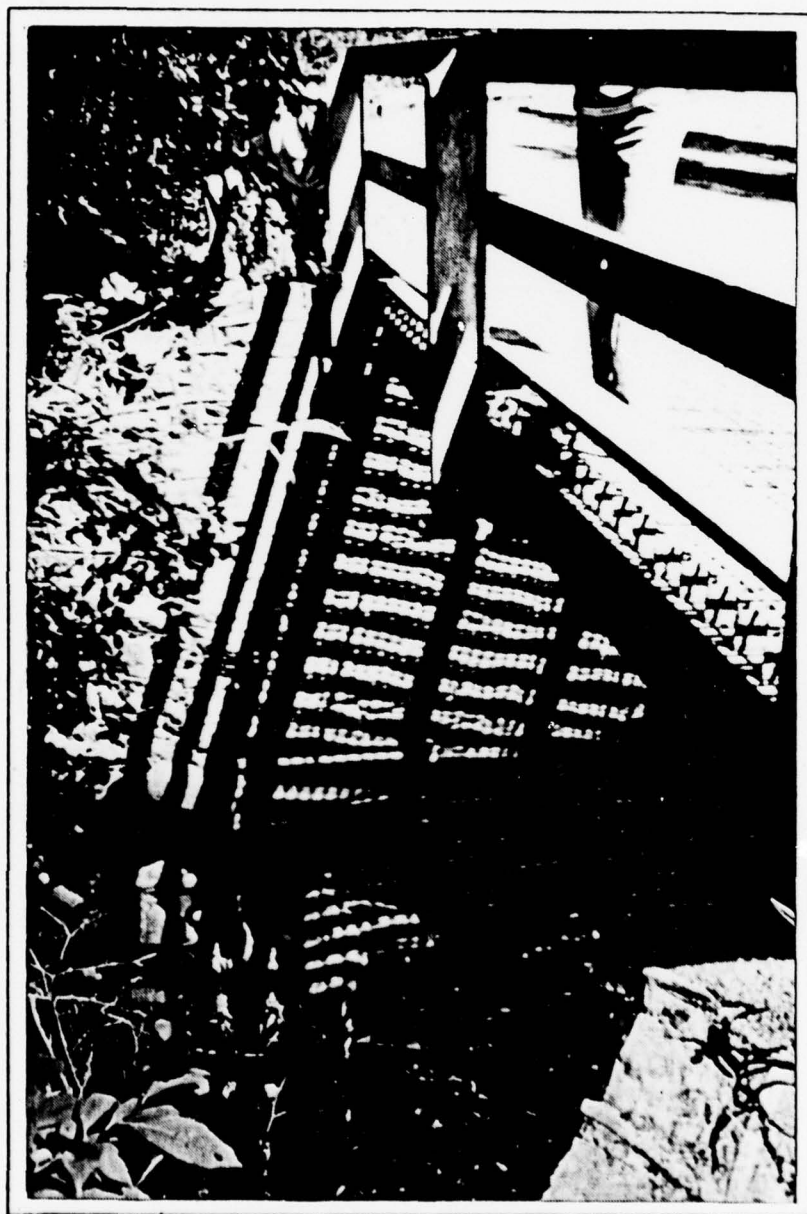
VIEW OF FIRST BRIDGE LOCATED  
DOWNSTREAM OF THE DAM.
